# Vibration Exposes Danger of Skipping Torque Protocols for Fasteners

Engineering Hardware · [engineeringhardware.com/news/vibration-exposes-danger-of-skipping-torque-protocols-for-fasteners](https://engineeringhardware.com/news/vibration-exposes-danger-of-skipping-torque-protocols-for-fasteners)

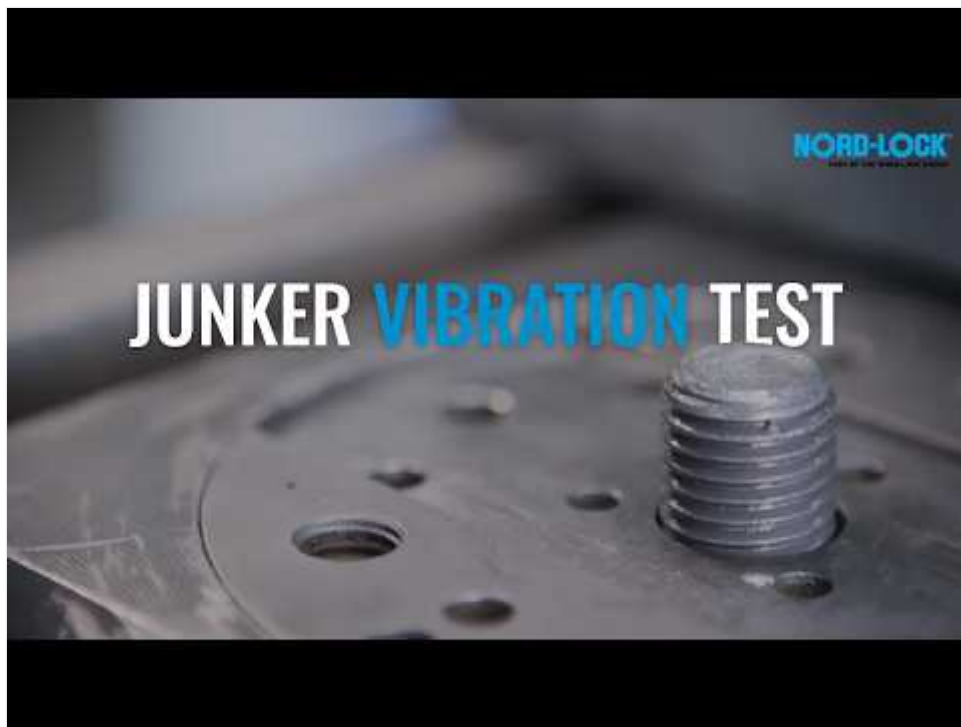
► Watch video: <https://www.youtube.com/watch?v=IKwWu2w1gGk>

**Nord-Lock Wedge-Locking Washers - Junker Vibration Test** — by Nord-Lock Group on YouTubeThe Junker vibration test, according to DIN 65151, is considered the most severe vibration test for bolted connections. In this video00a0...
